### **PROJECT #153K BEHAVIOR OF CORRODED PIPELINES UNDER CYCLIC PRESSURE**

Report Title: Project #153K Behavior of Corroded Pipelines under Cyclic Pressure	
Report Number: R8928	Project SAP Code: 1/07620

This report presents the results for Project #153K, "Behavior of Corroded Pipelines Under Cyclic Pressure".

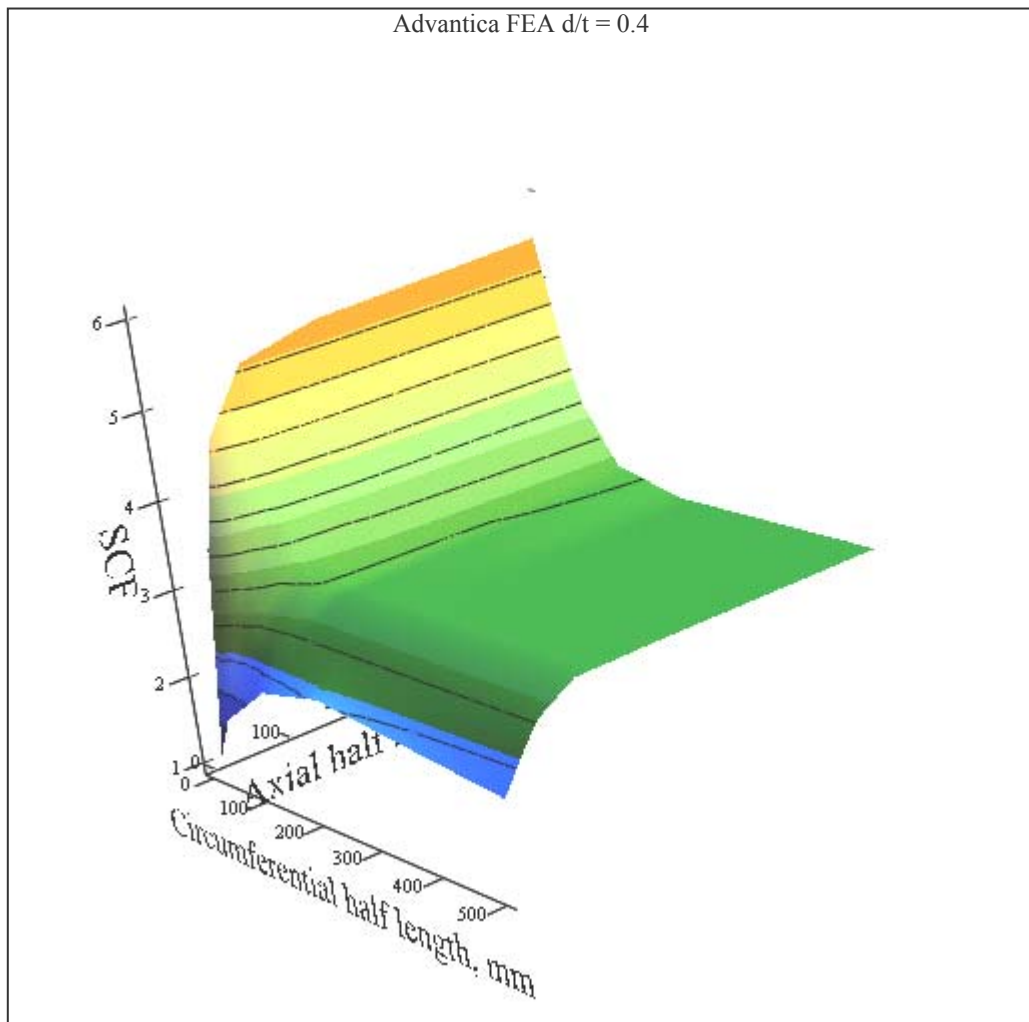
Figure 33. Surface plot of SCF results for a defect depth  $d/t=0.4$

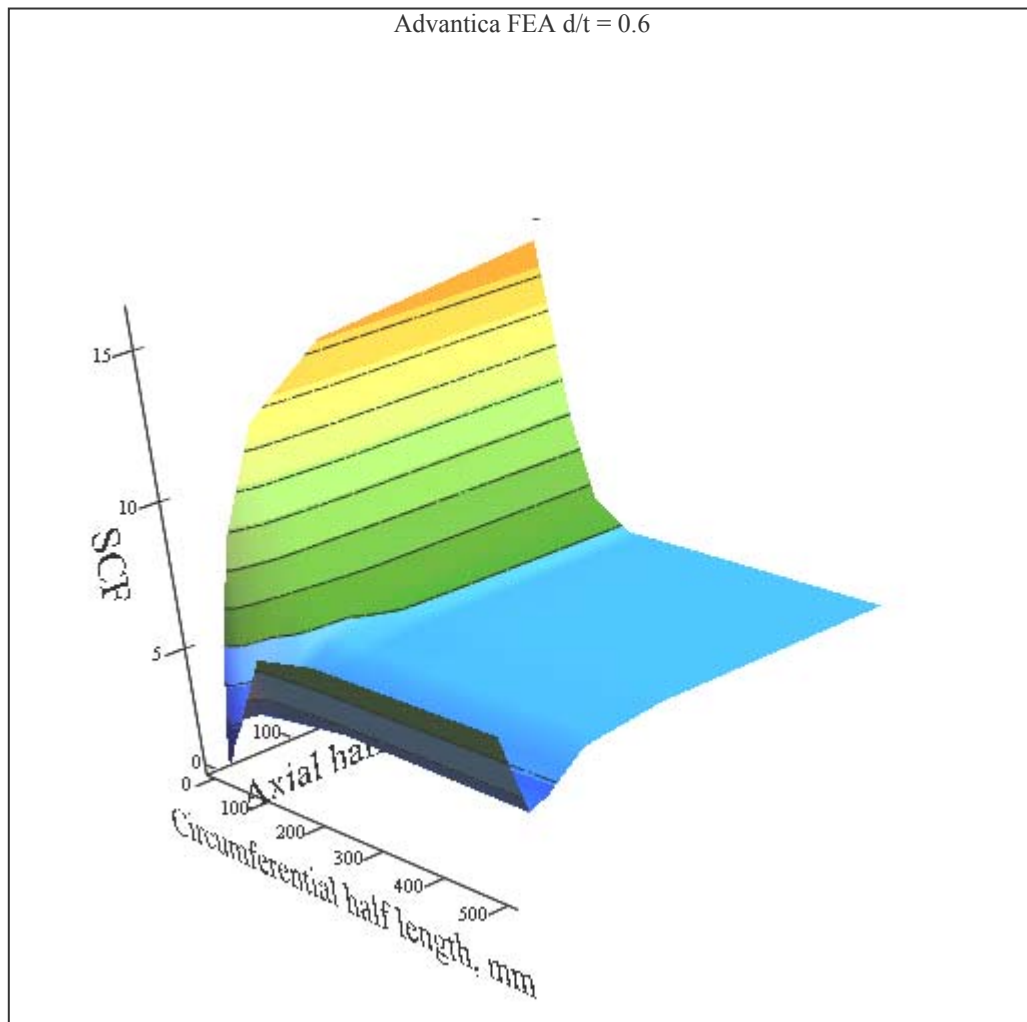
Figure 34. Surface plot of SCF results for a defect depth  $d/t=0.6$

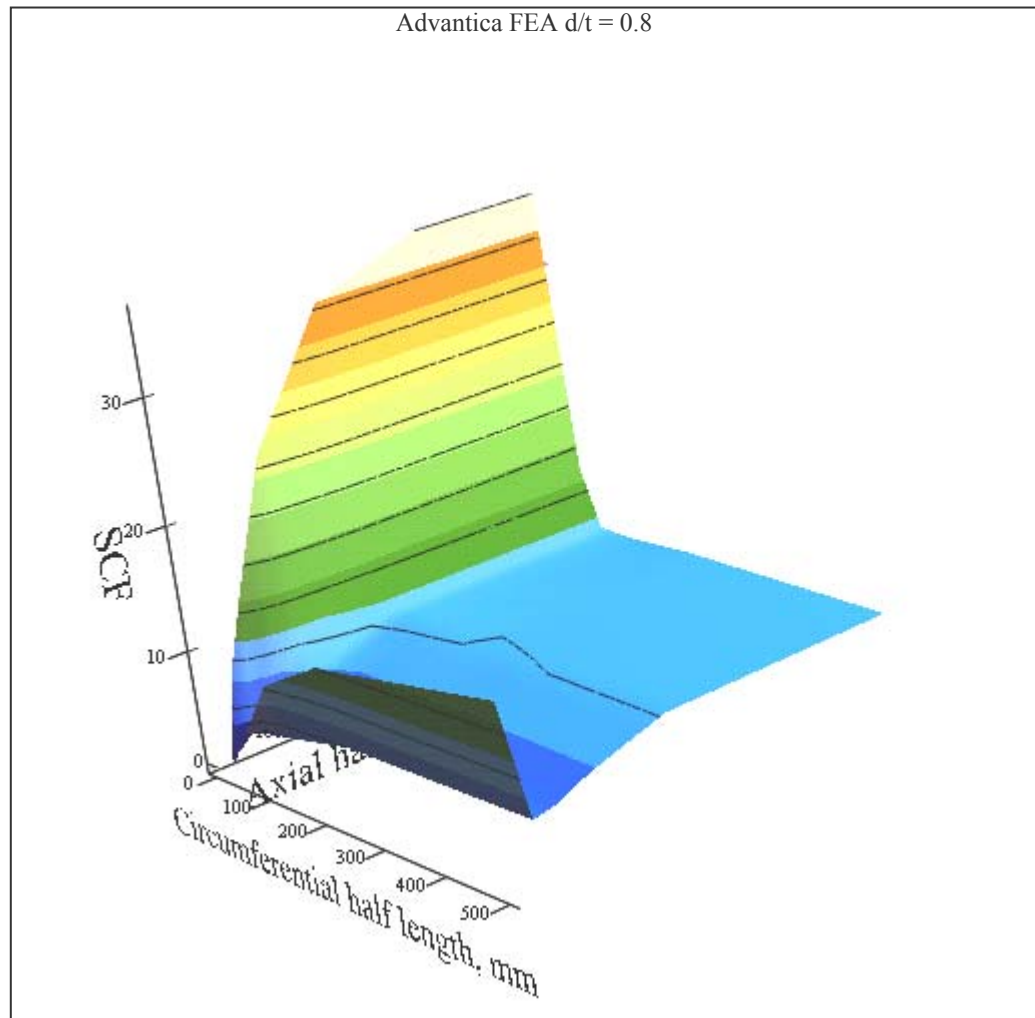
Figure 35 Surface plot of SCF results for a defect depth  $d/t=0.8$

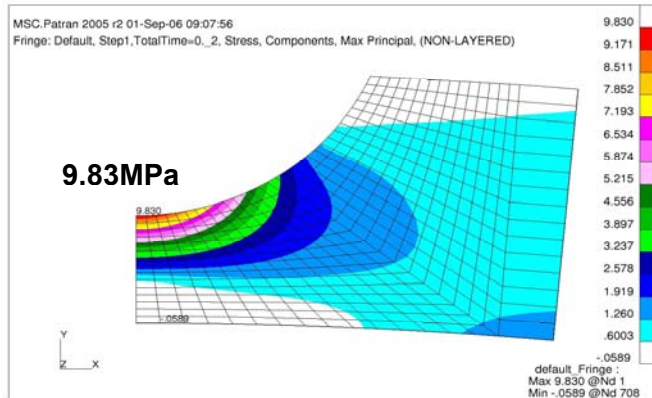
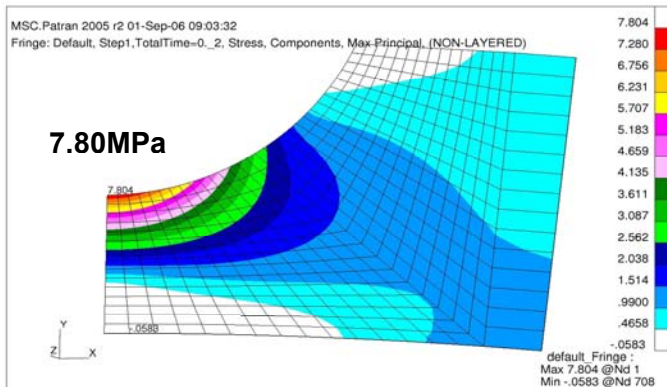
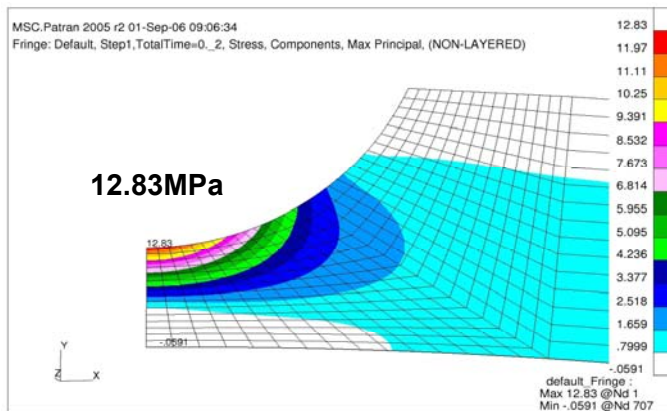
Figure 36. Plane strain finite element models showing the effect of an eccentric bore on the SCF

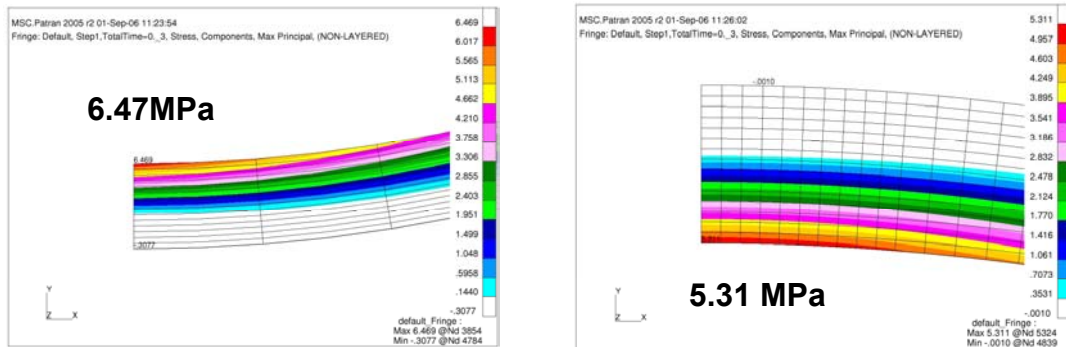
Figure 37. Local maximum principal stress contours for defect free pipe with an eccentric bore. Left, thinnest area; right, thickest area

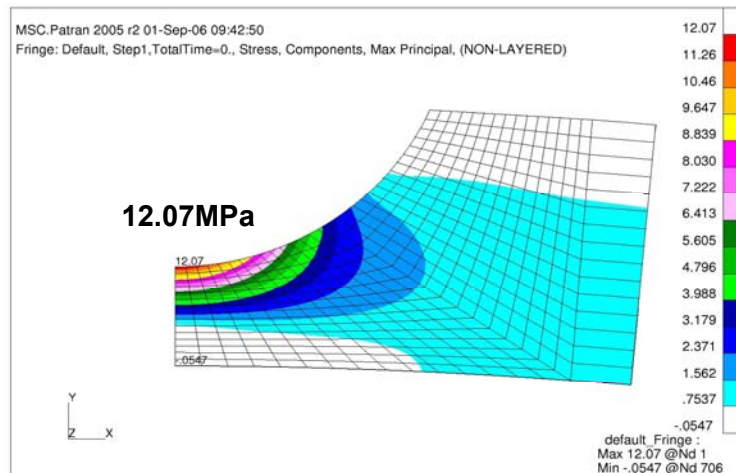
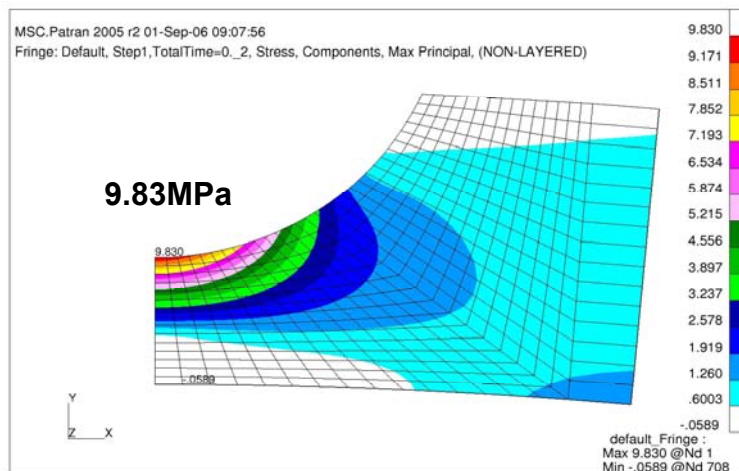
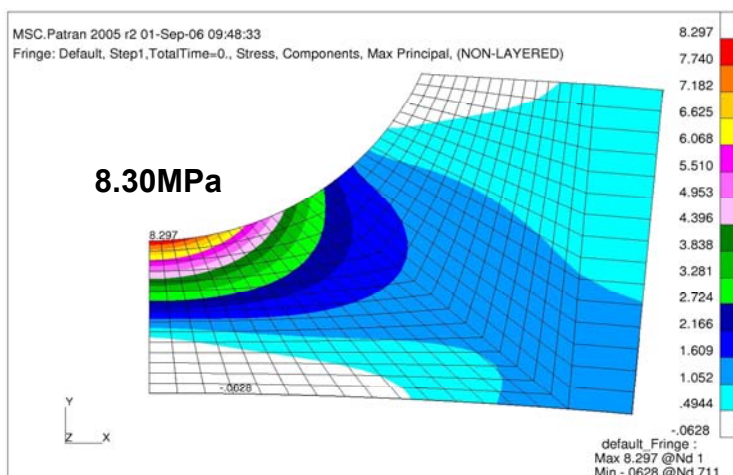
Figure 38. Effect of varying pipe wall thickness for a constant groove depth; Hoop stress  $1.0 \text{ N/mm}^2$  in each case
